SNAP-8 TOPICAL MATERIALS REPORT FOR 1962

VOL. III - SNAP-8 MERCURY CORROSION AND MATERIALS RESEARCH

SNAP-8 MERCURY CORROSION AND MATERIALS RESEARCH

Topical Report

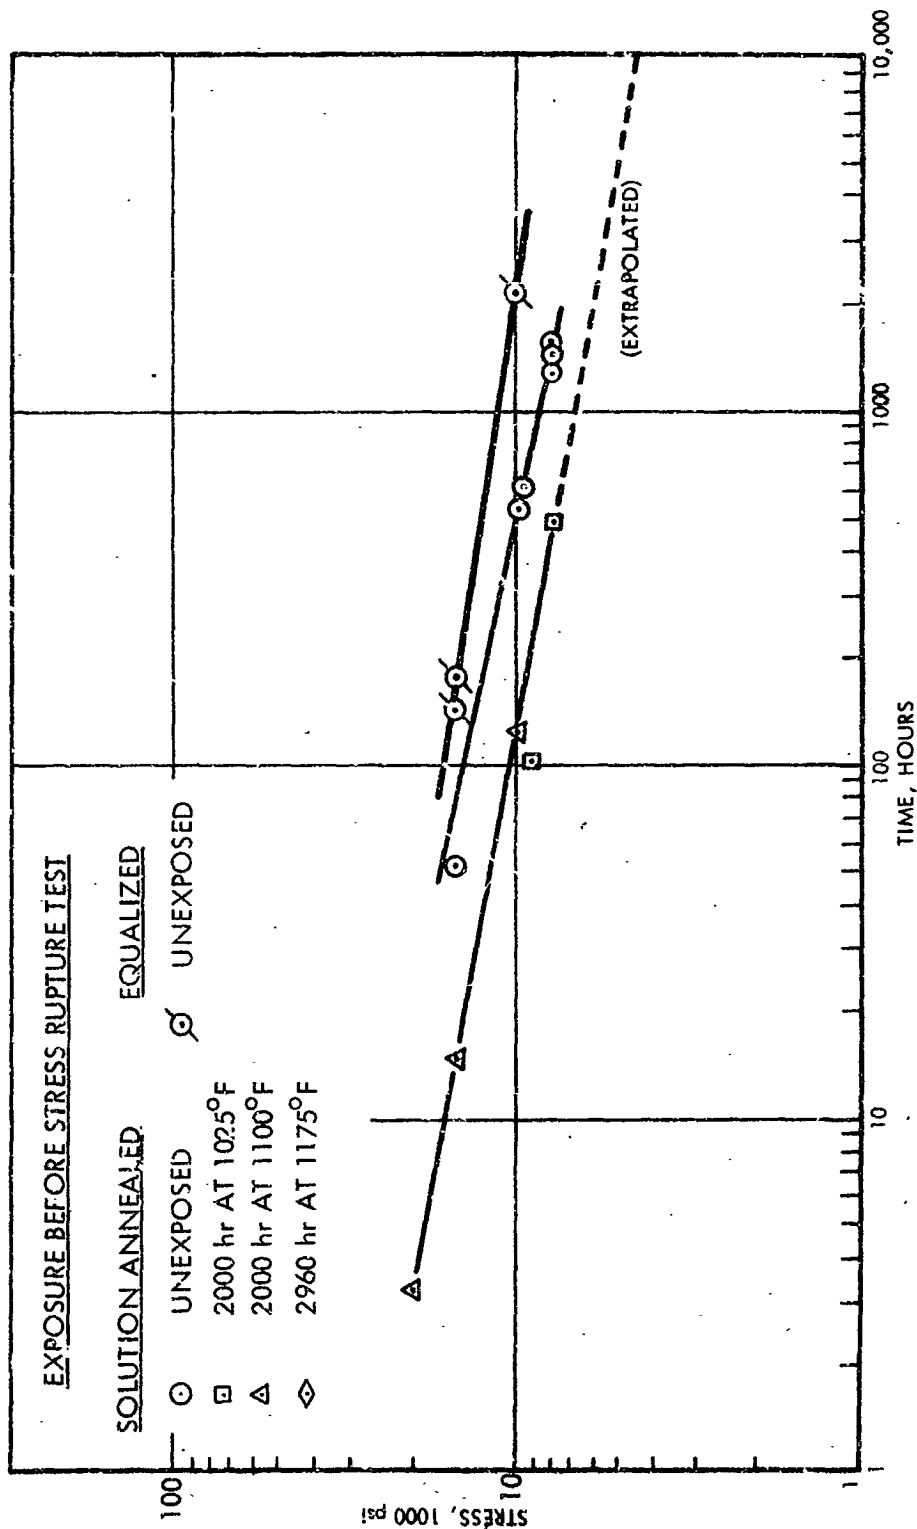
FIGURE 39. STRESS RUPTURE OF AM-350 AT 1300°F
